# Manhole Inspection Summary

Manhole # S21AA2020MH

**Location** Address: **5501 FALLS RD** Cross Street: **NORTHERN PKWY**

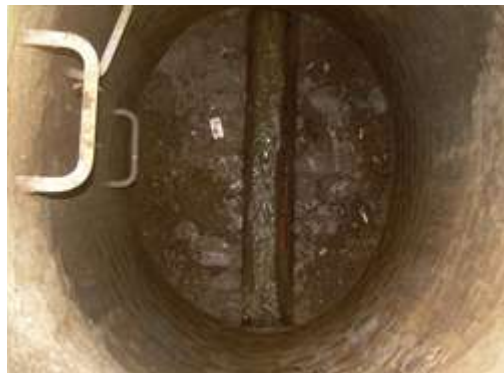
Top View

Evidence of surcharge - Bench debris.

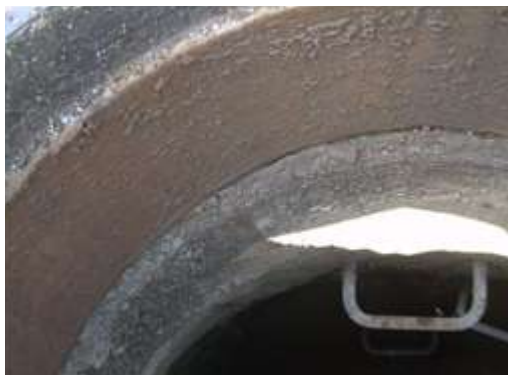
Defect

**Frame** Offset: **1** (in.) Condition: ☐ Sound ☐ Cracked ☒ **Leaks**

**Chimney / Frame Adjustment** ☒ Exists Material: **Brick** ☐ Parged Height: **10** (in.)  
Condition: ☒ Sound ☐ Cracked ☐ Root Intrusion ☐ Loose Brick ☐ Deteriorated  
Infiltration: ☐ None ☒ **Joint** ☐ Cracks ☒ **Mortar** ☐ Roots ☐ Wall

Frame leaks. Adjustment infiltration.

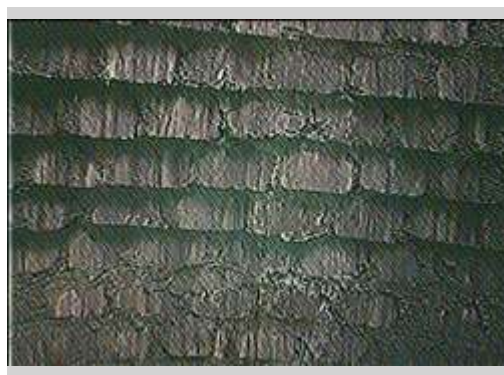
Defect

**Barrel** Material: **Brick** ☐ Parged  
Shape: **Circular** Diameter: **42** (in.) Length: (in.)  
Condition: ☐ Sound ☐ Cracked ☐ Root Intrusion ☐ Loose Brick ☒ **Deteriorated**  
Infiltration: ☐ None ☐ Joint ☐ Cracks ☒ **Mortar** ☐ Roots ☒ **Wall**

Barrel deterioration and infiltration.

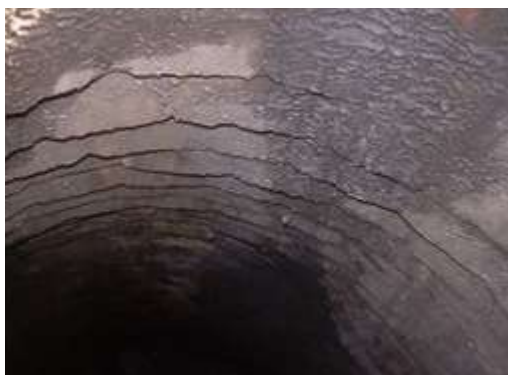
Defect

Adjustment and Barrel infiltration.

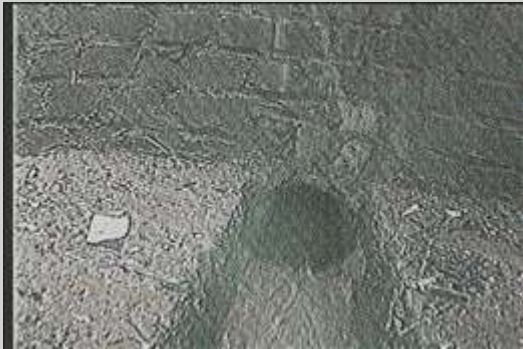
### 8 in. Circular Gravity Sewer Pipe Out @ 12 O'Clock

Infiltration: **None** Pipe Seal Cond: **Cracked**

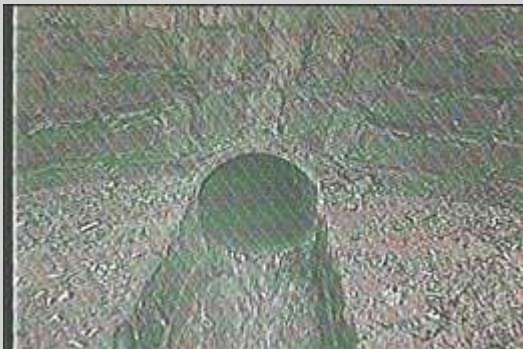
### 8 in. Circular Gravity Sewer Pipe In @ 6 O'Clock

Infiltration: **Evidence** Pipe Seal Cond: **Unknown**
